# **Gussteil- instandsetzung durch Cold Spray Anlagen**

**KNOWHOW  
WILHELMS**  
GmbH

Qualitätsmanagement und  
Gießereiberatung / Audits

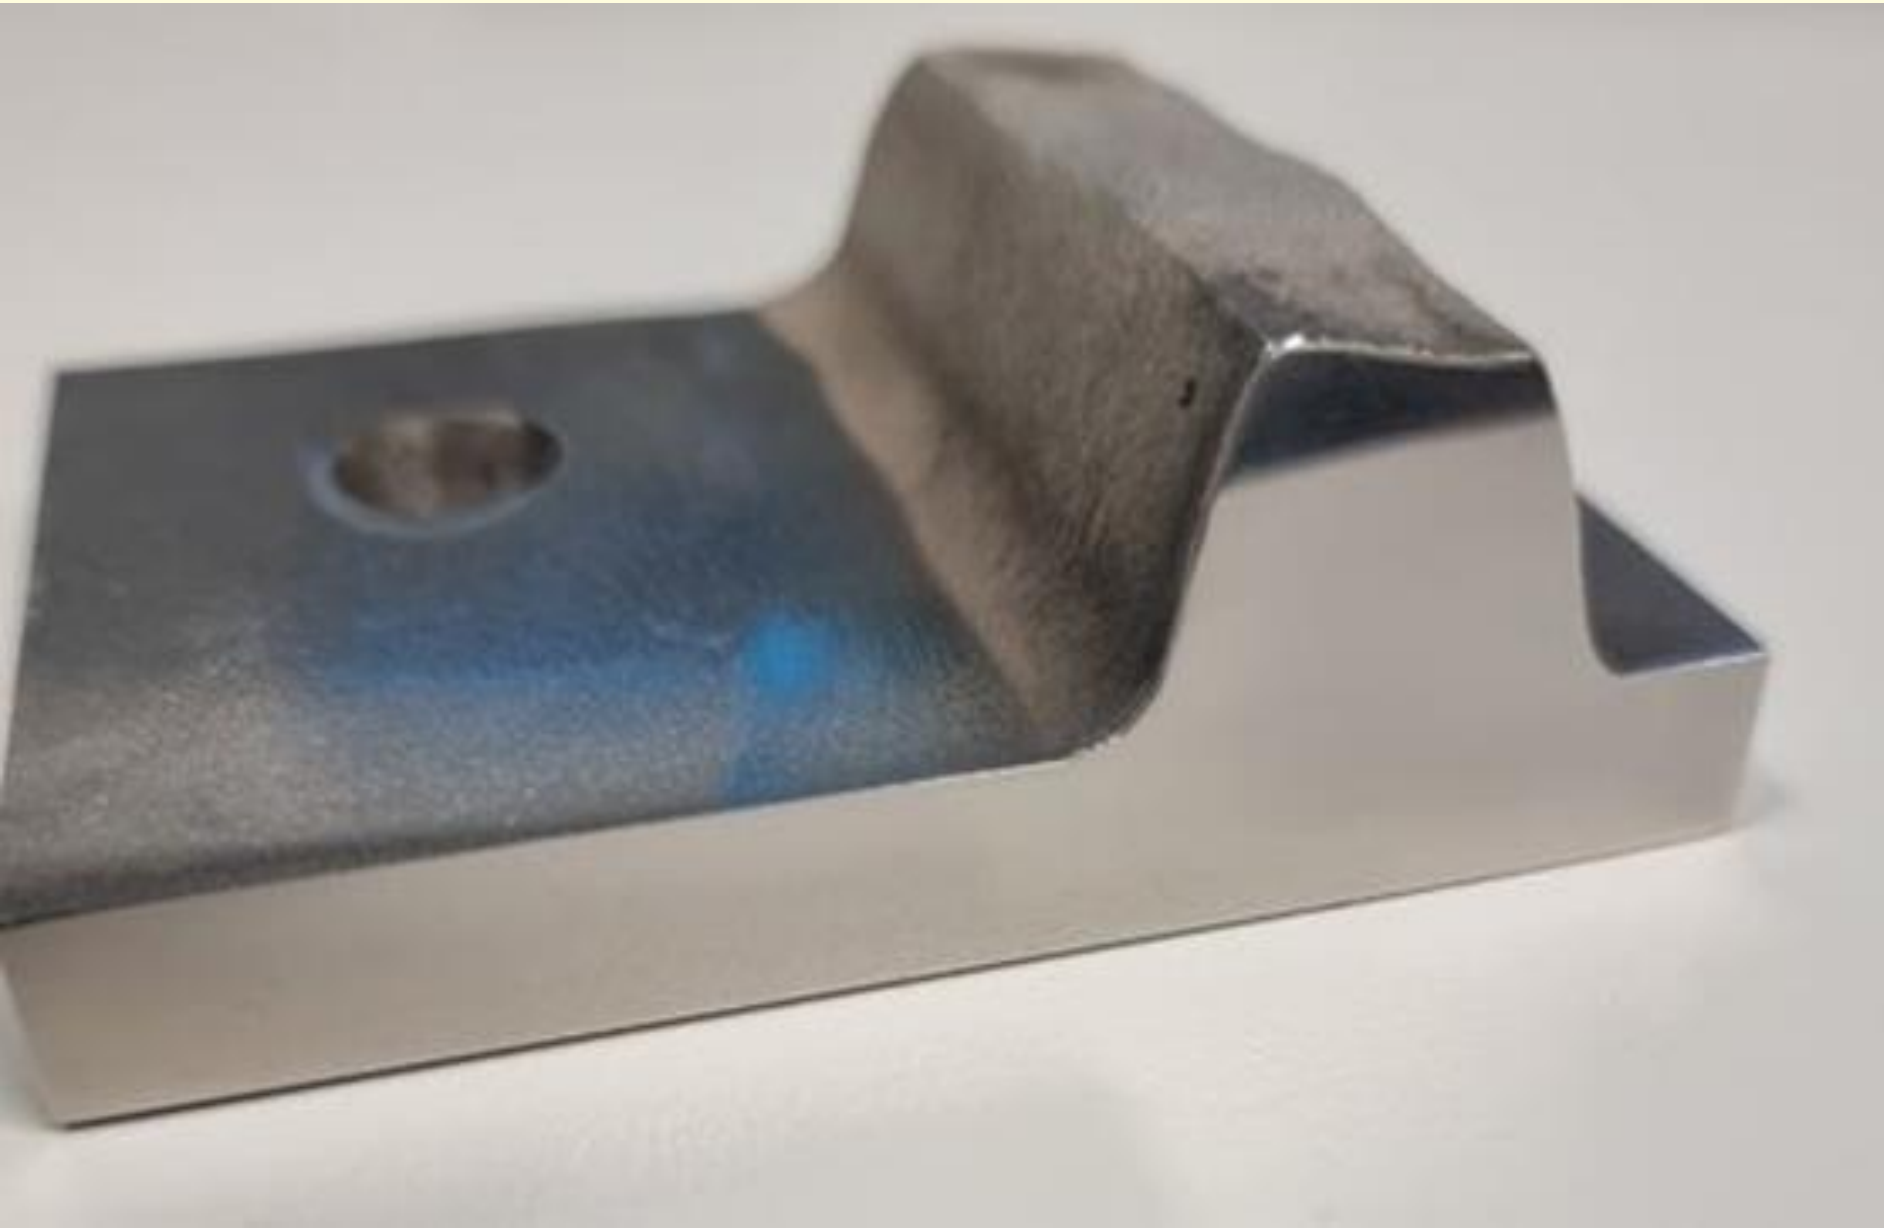
In der feingeschliffenen Oberfläche sind die Cold Spray Bereiche selten zu sehen.

Hier die aufgebrachte Rippe auf einer Platte

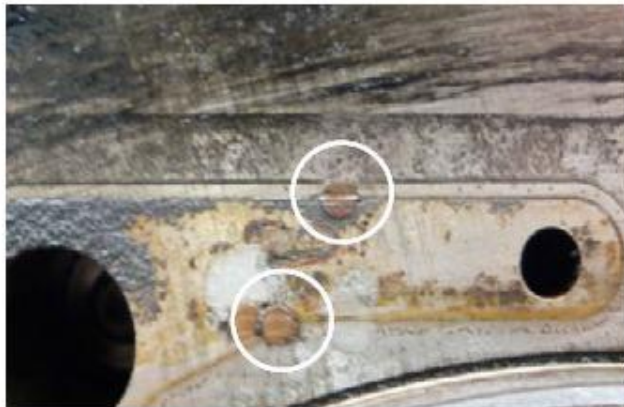
Faults in base material - epoxy repair

This section was originally repaired with metal epoxy, which quickly began to degrade after its 2,000 operational-hour rating. Titomic used a hard-wearing blend of Al, Zn, Al<sub>2</sub>O<sub>3</sub> to repair the passage. Pictured on the right, there is no visible wear after 6,500 operating hours.

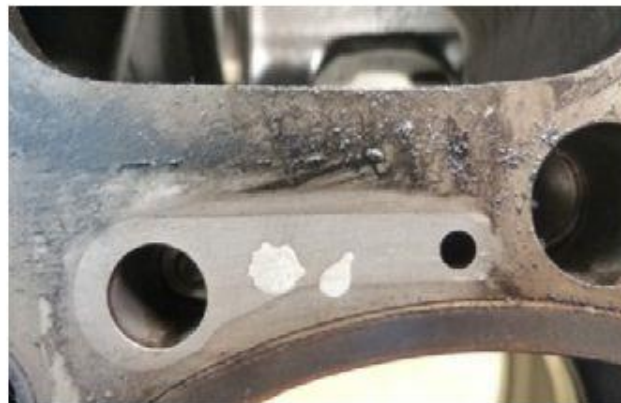
Resurfaced & repaired with D523

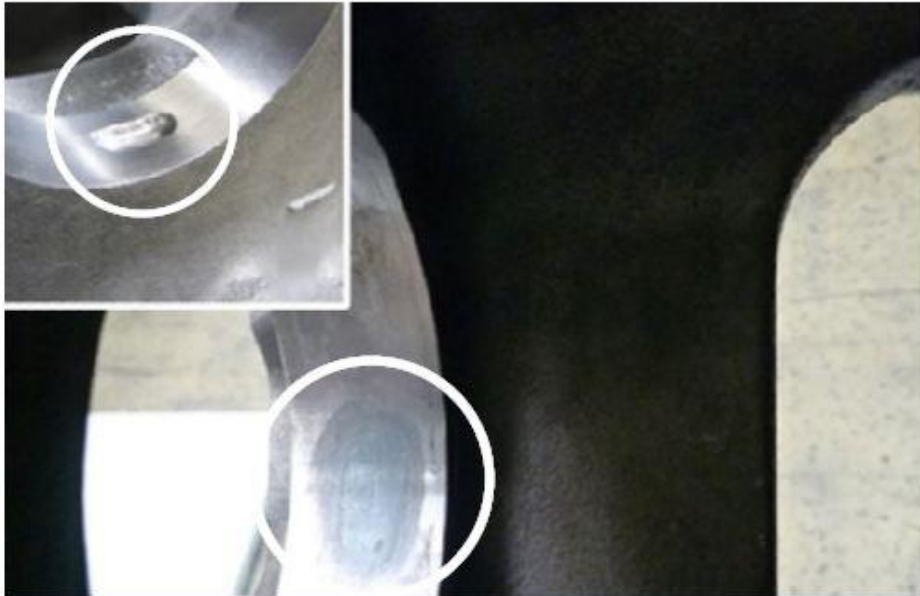
*Cold spray repair after 12,600 hours*

This camshaft was repaired using the hand-held D523 system, depositing a 6mm layer of Al, Zn,  $\text{Al}_2\text{O}_3$ . The image on the left shows the cold spray repair after 12,600 hours, with the image on the right taken after 24,600 operating hours, showing no visible wear, deformation, or defects.

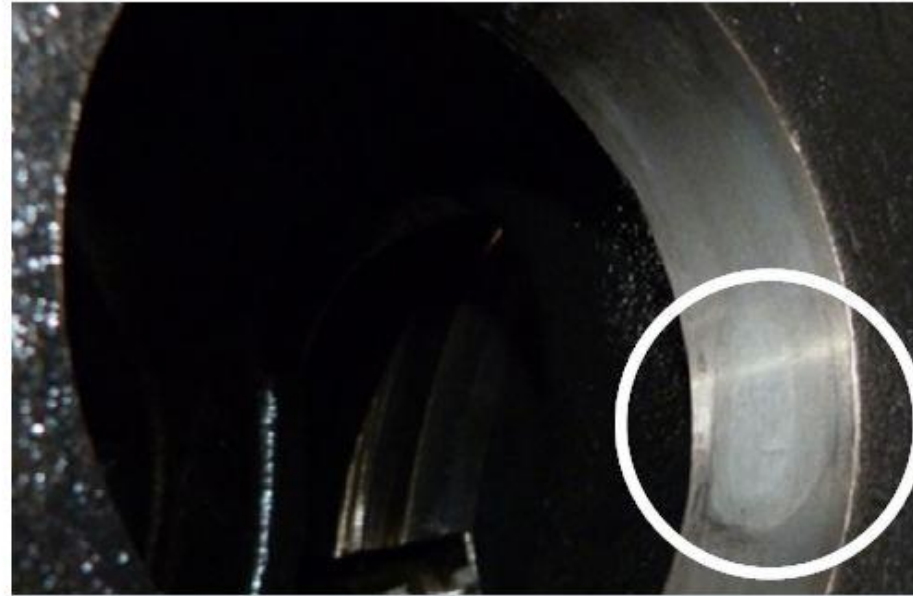
*Cold spray repair after 24,600 hours*

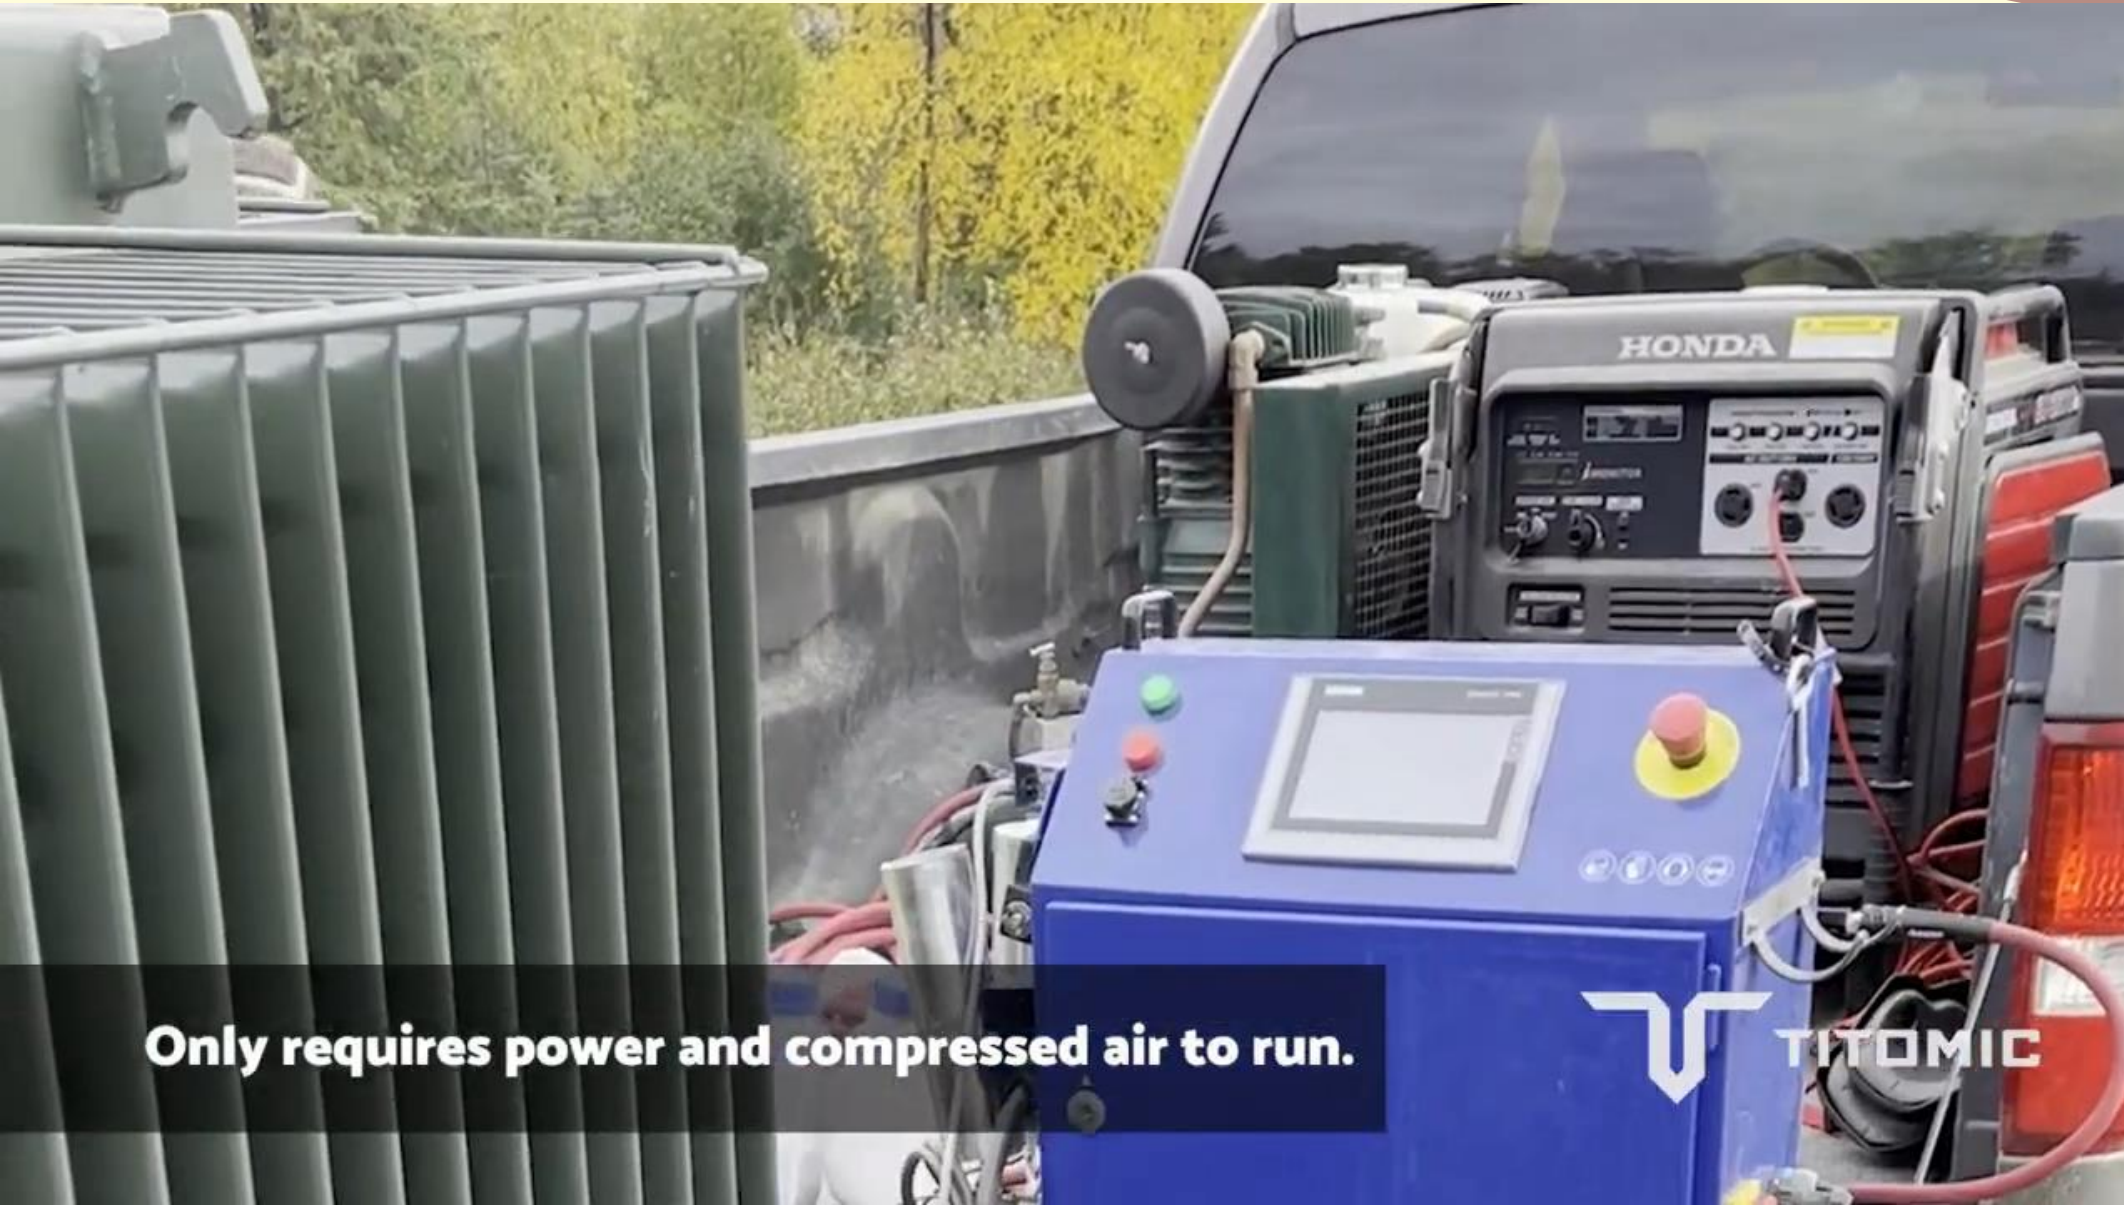
Luftdruck  
oder  
Stickstoff  
min.  
6 Bar  
konstant  
größerer  
Vol.

elektr.  
Strom  
220V  
10A

**Only requires power and compressed air to run.**

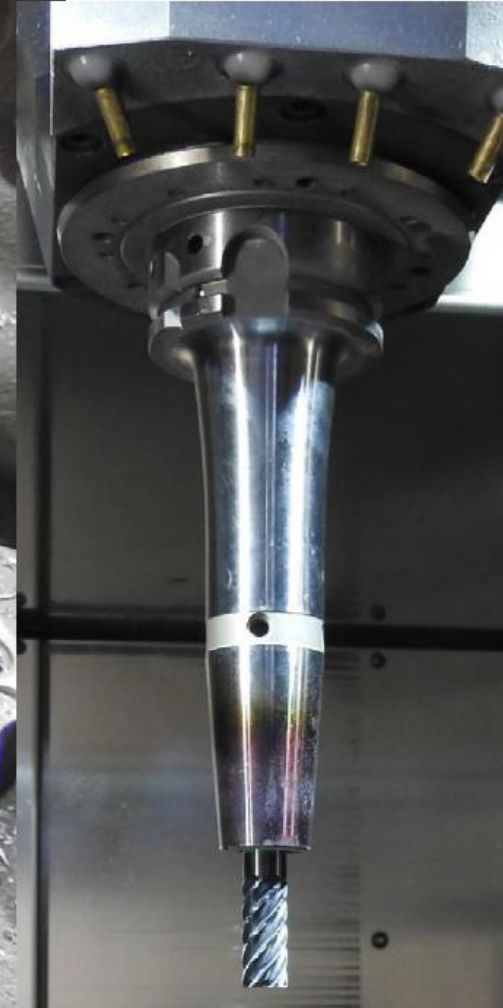
Potential use for dimensional restoration (replacing **Laser** repairs)

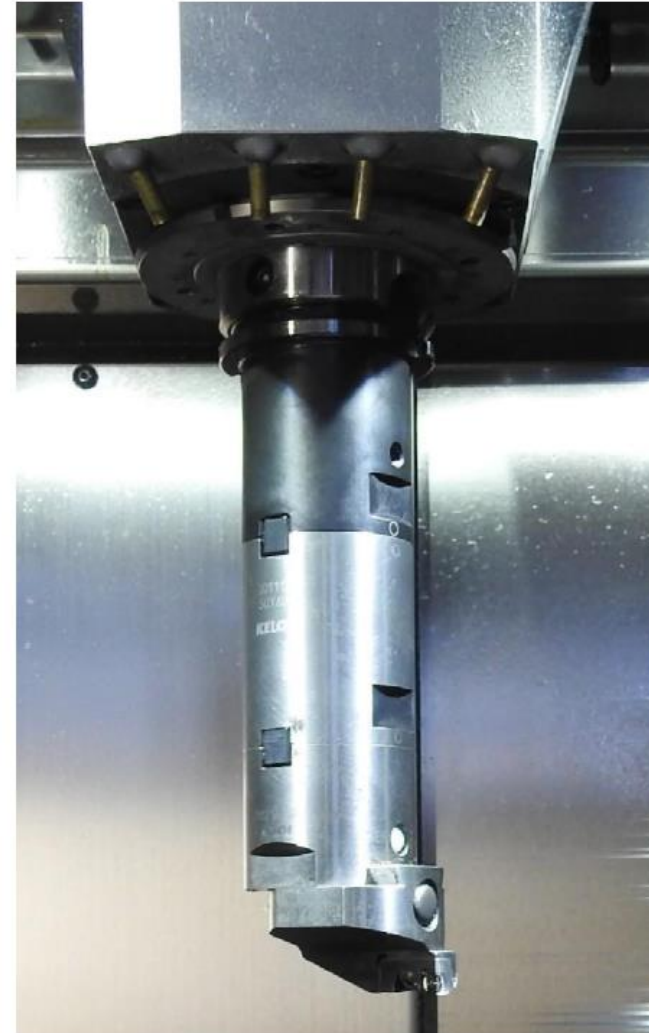
Potential use for dimensional restoration (replacing Plasma repairs)

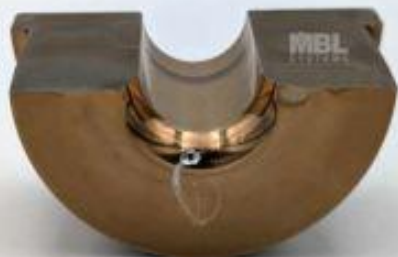
unbearbeitete Schadstelle

Die Schadstelle hat einen Durchmesser von ca. 3,0 mm und eine Tiefe von ca. 1,5 mm.

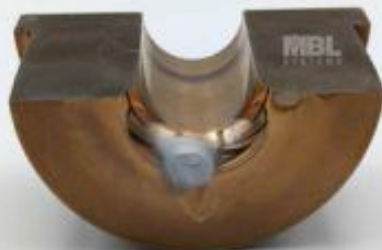
nach dem Kaltgasspritzen

Für die Reparatur mittels Kaltgasspritzen wurde die Auswahl des passenden Pulvers vorgenommen.

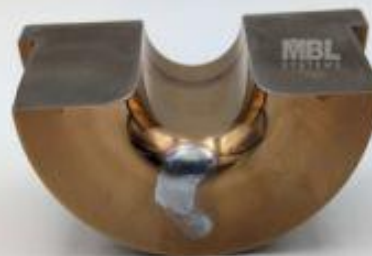
nach der mechanischen  
Bearbeitung

Um die Originalkontur des Bauteils wiederherzustellen, wurde eine mechanische Bearbeitung durchgeführt.
